COMMONWEALTH OF KENTUCKY
BEFORE THE PUBLIC SERVICE COMMISSION

LOUISVILLE GAS AND ELECTRIC COMPANY)	
)	
_____)	CASE NO. 97-174
)	
ALLEGED VIOLATIONS OF ADMINISTRATIVE)	
REGULATION 807 KAR 5:041)

UTILITY ACCIDENT INVESTIGATION REPORT

INVESTIGATION REPORT

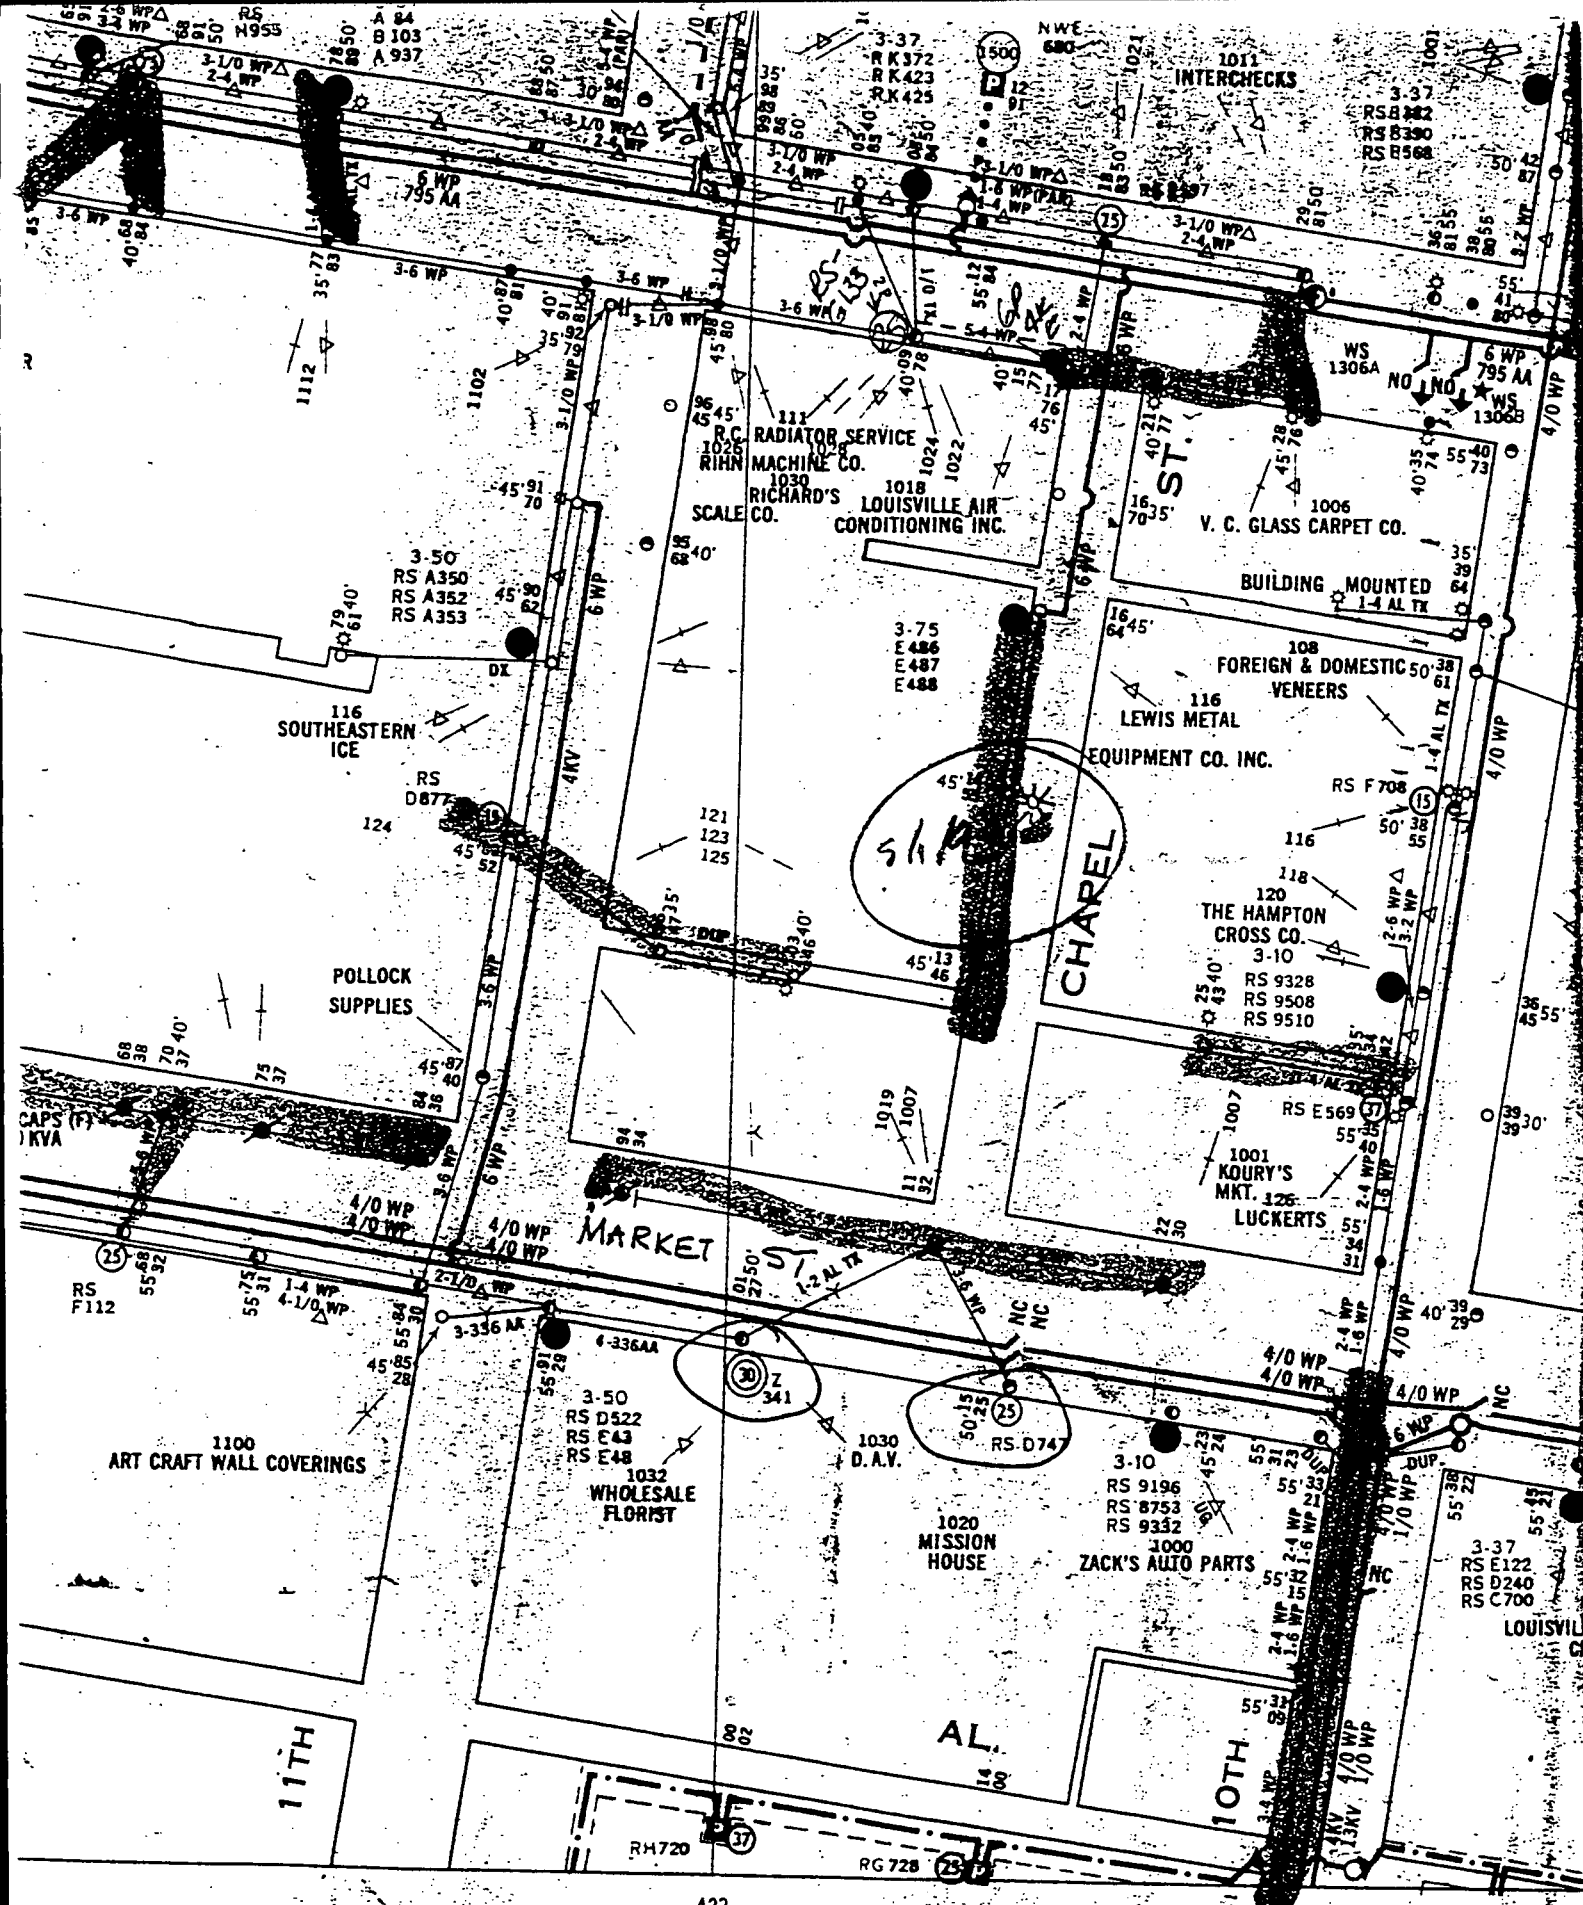
The following conditions were noted. A light standard located on the south side of Market Street between poles #E2-2467 and #E2-2512 had a disconnected wire on its west side. This wire is fed by an incandescent lighting circuit tab located on pole #E2-2468. This pole was in the process of being replaced and a new pole was set on the east side of it on October 16. Extension arms were attached to pole #E2-2468 to spread the wires (a normal procedure for pole replacement). The lower extension arm held the end of a 240 V secondary line, and a guy wire holding it in place. The other end of the guy was attached to pole #E2-2467 (where two other guy wires also attached from pole #E2-2468). The guy wire in question was removed on the evening of October 16 by Kevin Rhodes, Line Technician. LG&E's correction order #827859 states, "Found temporary head guy laying on incandescent circuit and burning on ground. Cleared up okay." (Note: Notation of "temporary" on correction order was an error. Head guy was permanent.)

There are two trees involved in this incident. The larger tree, directly in front of 1020 West Market Street, is the one Mr. Sheard advises he touched, and a smaller tree, which is located just west. The larger tree has limbs which have grown into the incandescent wire. The smaller tree suffered fire damage on the evening of October 16. All that remains of the smaller tree is a burned stump. The fire department removed the rest of the tree on October 16. The concrete on the sidewalk surrounding the stump of the small tree contains several burn marks. According to Mr. Hasch, these are indicative of incandescent circuit voltage.
